Mines Safety Alert 308

Arc flash and blast when 1000V circuit breaker reset

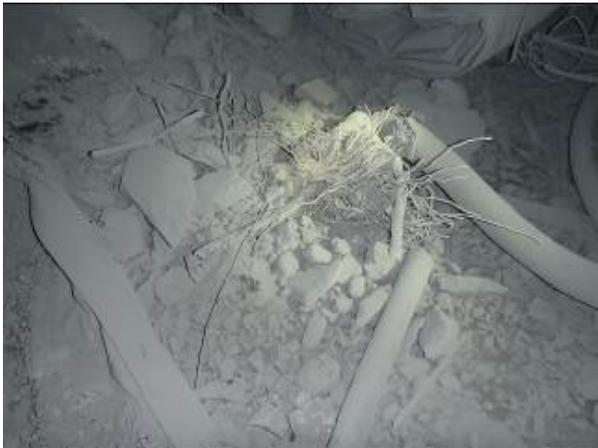
The fan starter's steel wire armoured cable was damaged by blasting from the mining operation, shorting the three phase conductors to earth (see below).

1. Ensure enclosures are fit for purpose and an arc flash assessment is taken into account when determining that risks are at acceptable levels.
2. Install any arc barriers provided by the circuit breaker manufacturer.
3. Ensure circuit breaker cable connections are adequately insulated with materials appropriate for the environment and application.

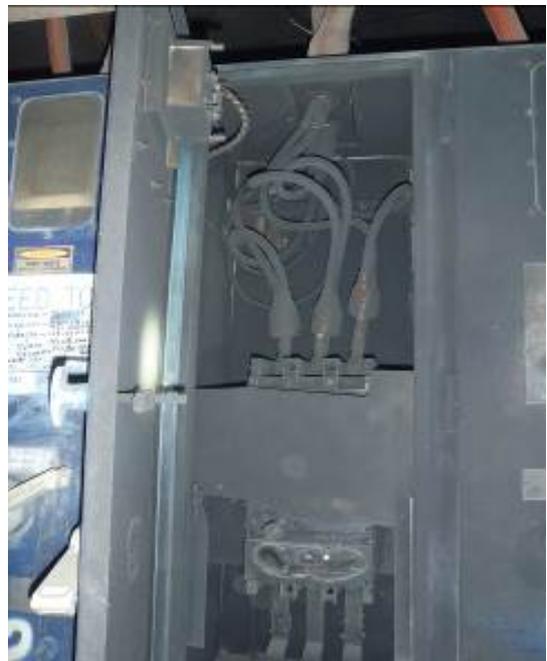
It appears he stood in front of the switchboard to reset the circuit breaker. An arc flash and blast then blew the door open (see below).

The electrician received serious burns to the upper part of his body and both sides of his face. The electrical fault was cleared by overcurrent protection on the 11kV side of the substation.

The circuit breaker was not fitted with phase barriers to avoid arcing between the phases.

Contamination inside the enclosures due to the underground environment was aggravated by high humidity.

4. Regular maintenance and inspection of substations and switchboards at the mine must effectively monitor the safety of the electrical installation and its protective features (For example. protection settings, exposed live parts and contamination).

5. Avoid standing in front of circuit breakers and switches on switchboards when operating them, to avoid the potential projection of arc flashes or blasts.

6. Wear fit for purpose personal protective equipment during electrical switching activities.
7. Maintenance personnel must be competent and aware of the safety procedures when performing electrical work in substations and switchboards.
